BATTERY CERTIFICATE

AVILOO
BATTERY DIAGNOSTICS

CERTIFICATE NUMBER: F740CE30-21AB-4CE6-A120-CA91D2A1F037

BRAND: MINI
MODEL: Countryman E - 66,5 kWh

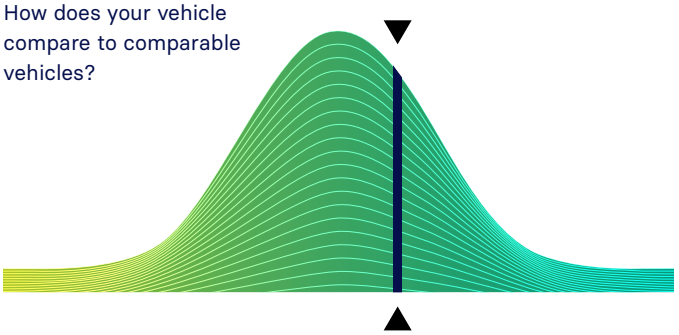
Independent
STATE OF HEALTH (SOH)

98.7 %

EXCELLENT HEALTH - NO ABNORMALITIES DETECTED
