BATTERY CERTIFICATE

AVILOO
BATTERY DIAGNOSTICS

CERTIFICATE NUMBER: 137EED95-548C-430E-B213-026114135E0F

BRAND: Xpeng
MODEL: G6 - 87,5 kWh

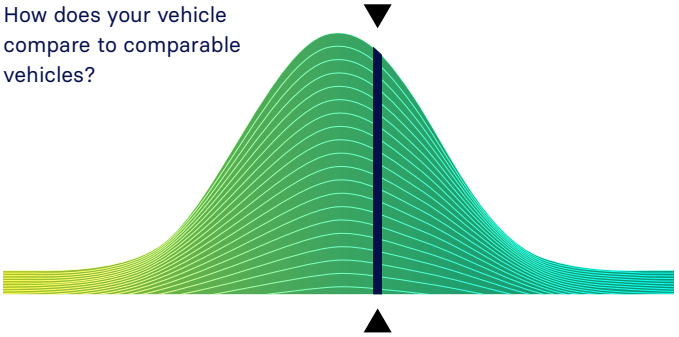
Independent
STATE OF HEALTH (SOH)

98.9 %

EXCELLENT HEALTH - NO ABNORMALITIES DETECTED
